**Fatigue Damage Mechanisms of Advanced
Hybrid Titanium Composite Laminates**

A Thesis
Presented to
The Academic Faculty

In Partial Fulfillment
of the Requirements for the Degree
Master of Science in Mechanical Engineering

Georgia Institute of Technology
November 1999

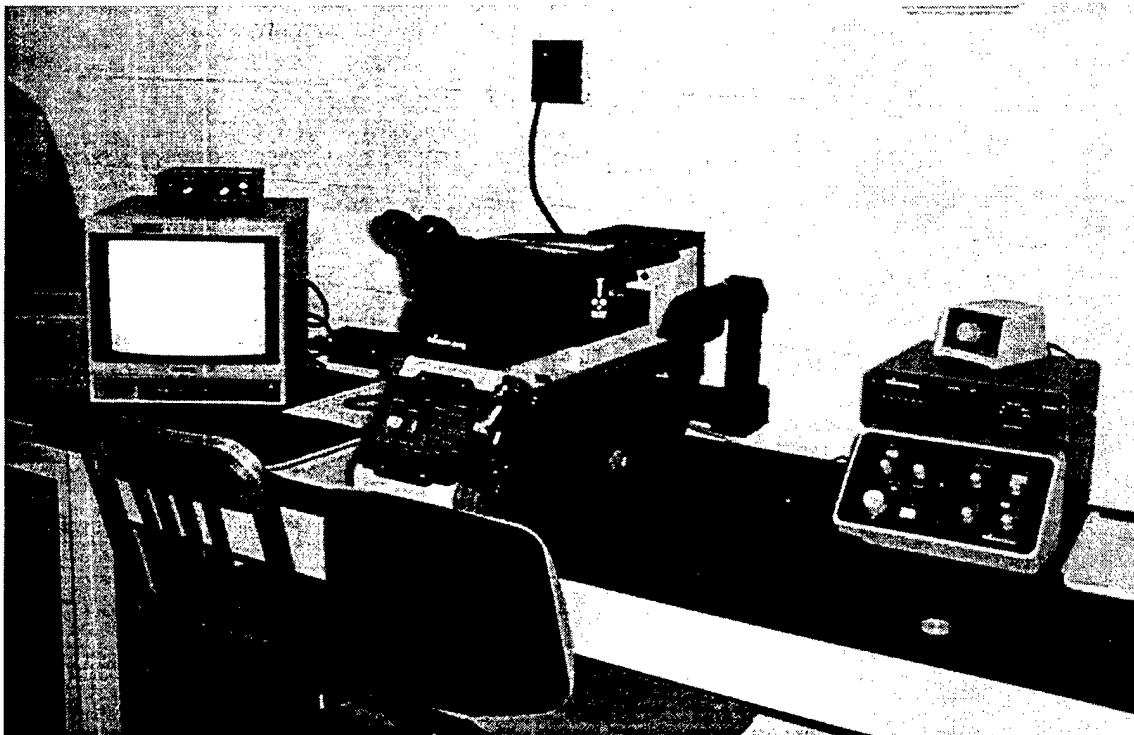
Figure A.6 Optical microscope with instant camera
